> Re: *Barbara Craw et al., v. Hometown America, LLC, et al.*, Case 18-cv-12149-LTS Completion of Stormwater Management System Improvement Projects Oakhill Settlement Agreement, Section III.C.3 (Doc. 171-1, filed May 6, 2021)

RE: **100 Shanley Drive Drainage** Oakhill Community 1003 Oakhill Avenue Attleboro, MA 02703

### FIELD REPORT #7

Client:	Hometown Oak Hill	Report Date:	December 22, 2020		
Project:	Site Observation	A&M Project #:	1830-10		
Location:	92 & 93 Such Drive	Contractor:	n/a		
Weather:	Rain	Temperature:	40°		
Date of Site Visit:	December 14, 2020				
Time:	<i>From</i> : 9:45 am <i>To</i> : 10:15 am				
Present at Site:	Present at Site: Phil Cordeiro (A&M), Peter Conant (Hometown America)				
Reported By:	Phil Cordeiro				
Attachments:	Onsite photograph report

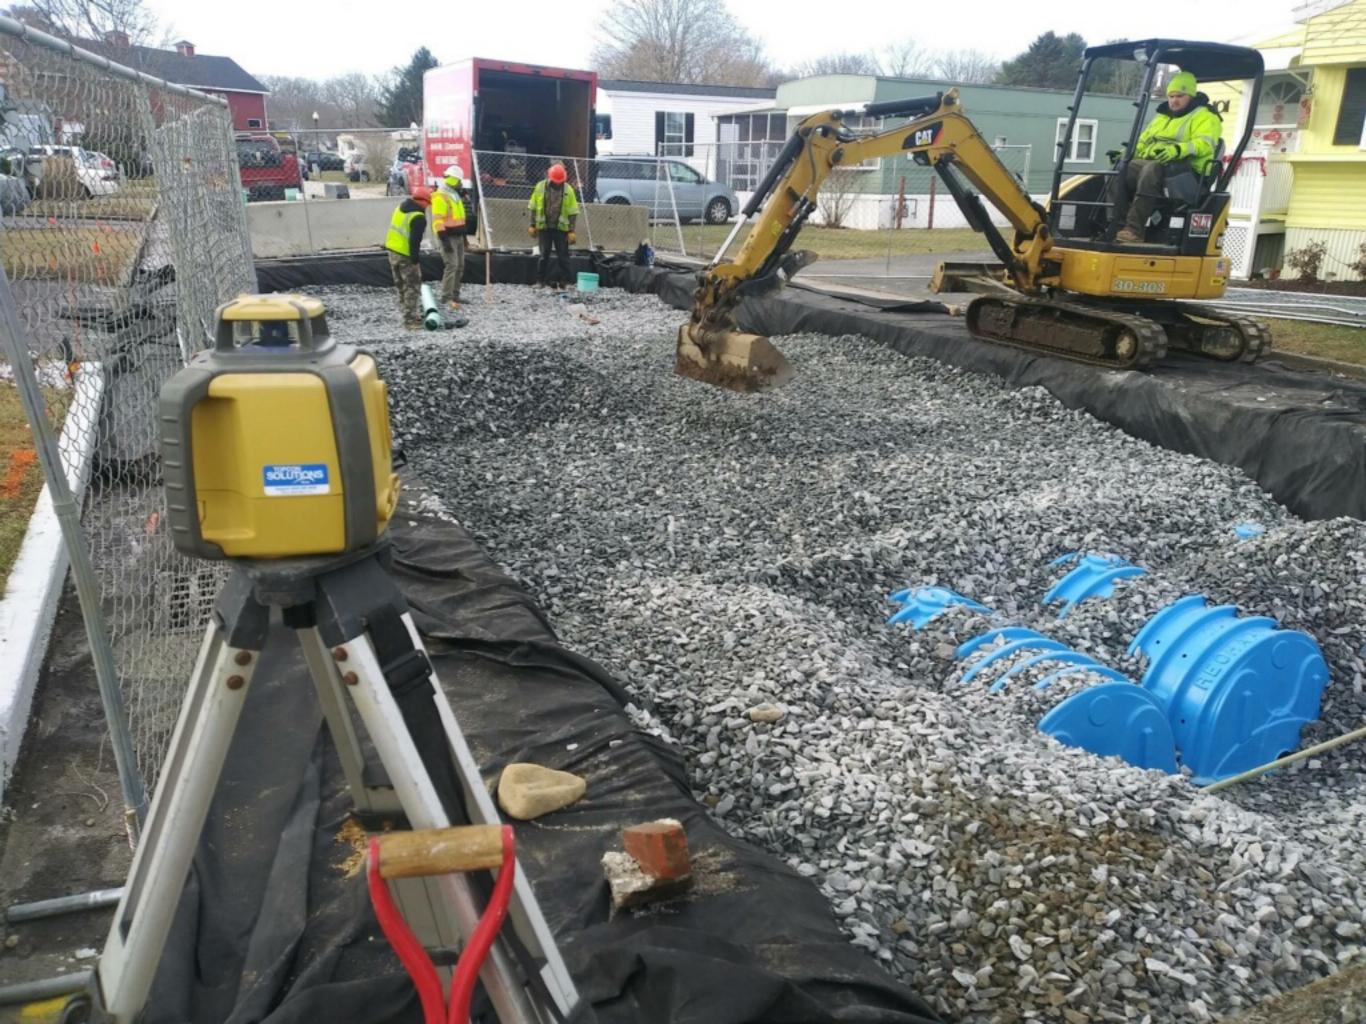
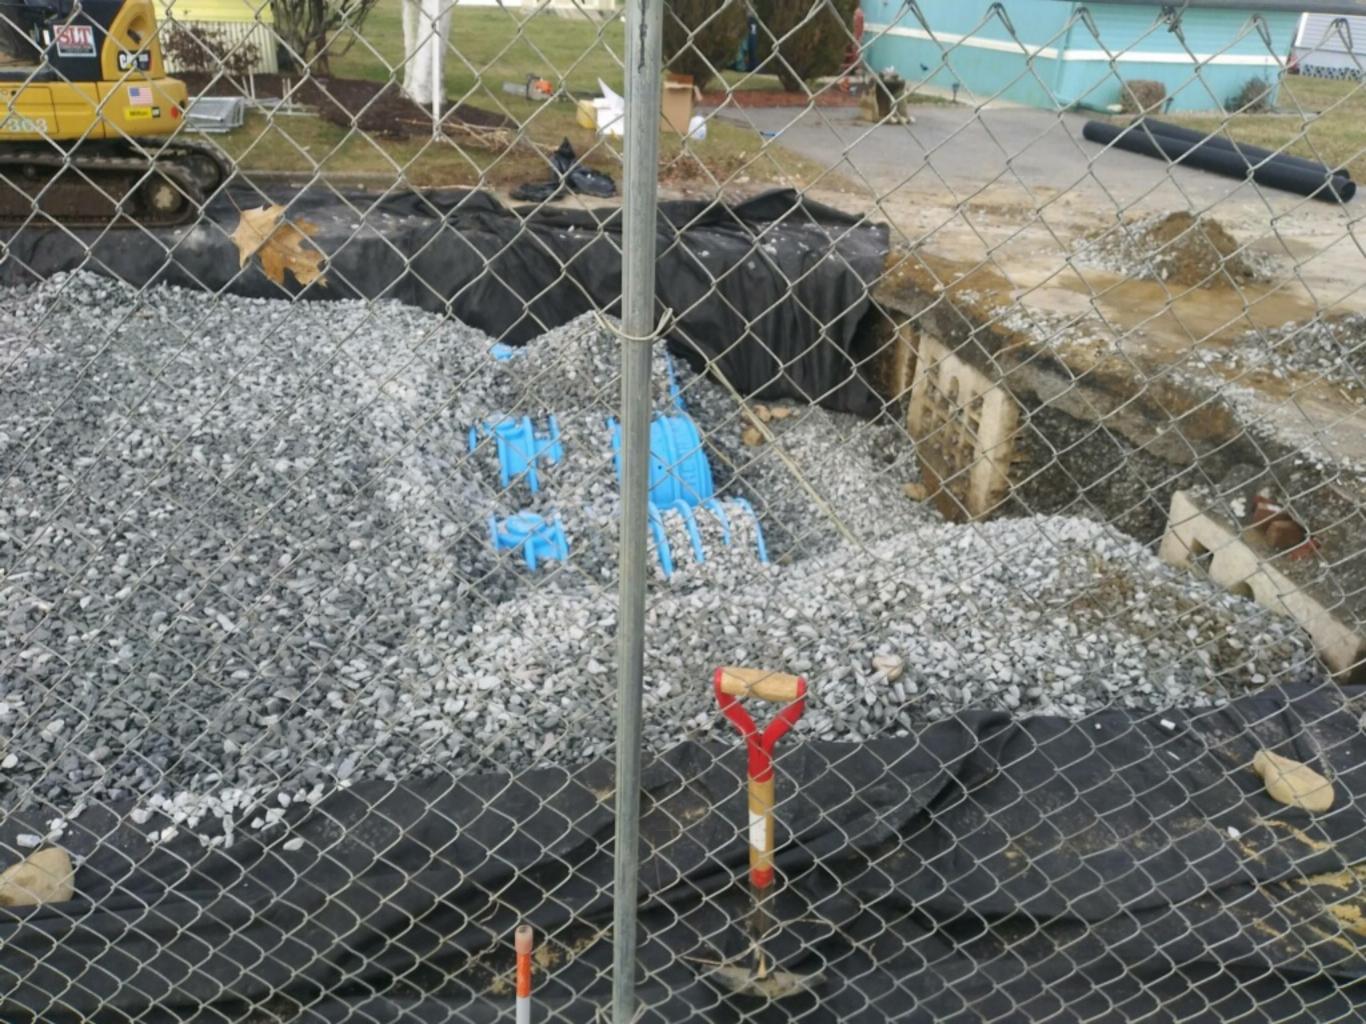
Attached herewith are two photos provided by the contractor SLT which document the construction of the system in compliance with the Construction Plan titled Drainage Improvement Plan, last revised 1/5/21 prepared by Kelly Engineering Group, Inc. (KEG). The two photos included show the completion of the system with stone encasement and filter fabric.

KEG was not on site for the entire construction of the drainage system however did perform a site visit on 1/21/21 to inspect the bottom of the recharge system for soil conditions.

During that site the contractor had excavated to approximately elevation 140.5 which is the proposed bottom of the system. KEG found old top soil that was silty at this elevation. KEG then instructed them to dig approximately 6" deeper where a sandier material was found. A little deeper well drained sands and gravels were found.

KEG instructed SLT to remove the 6" of old top soil from elevation to 140-140.5 to remove the restrictive layer to help recharge better. KEG also requested they provide 4 spots within the system to provide plunge pools or wicks top better infiltrate down to the well drained sands and gravels. Photos were requested to document the system construction.

From the site inspection, photos provided and shop drawing submittal the drainage system appears to be constructed in substantial compliance with the construction plan.
