Re: Barbara Craw, et al., v. Hometown America, LLC, et al., Case 18-cv-12149-LTS (D. Mass.)

Oak Point Stormwater Management System Operation & Maintenance Program Annual Report No. 1, for Year 1 of the Judicially Enforceable Period – covering the period from February 26, 2023 through February 25, 2024

DRAINAGE OPERATION & MAINTENANCE PLAN

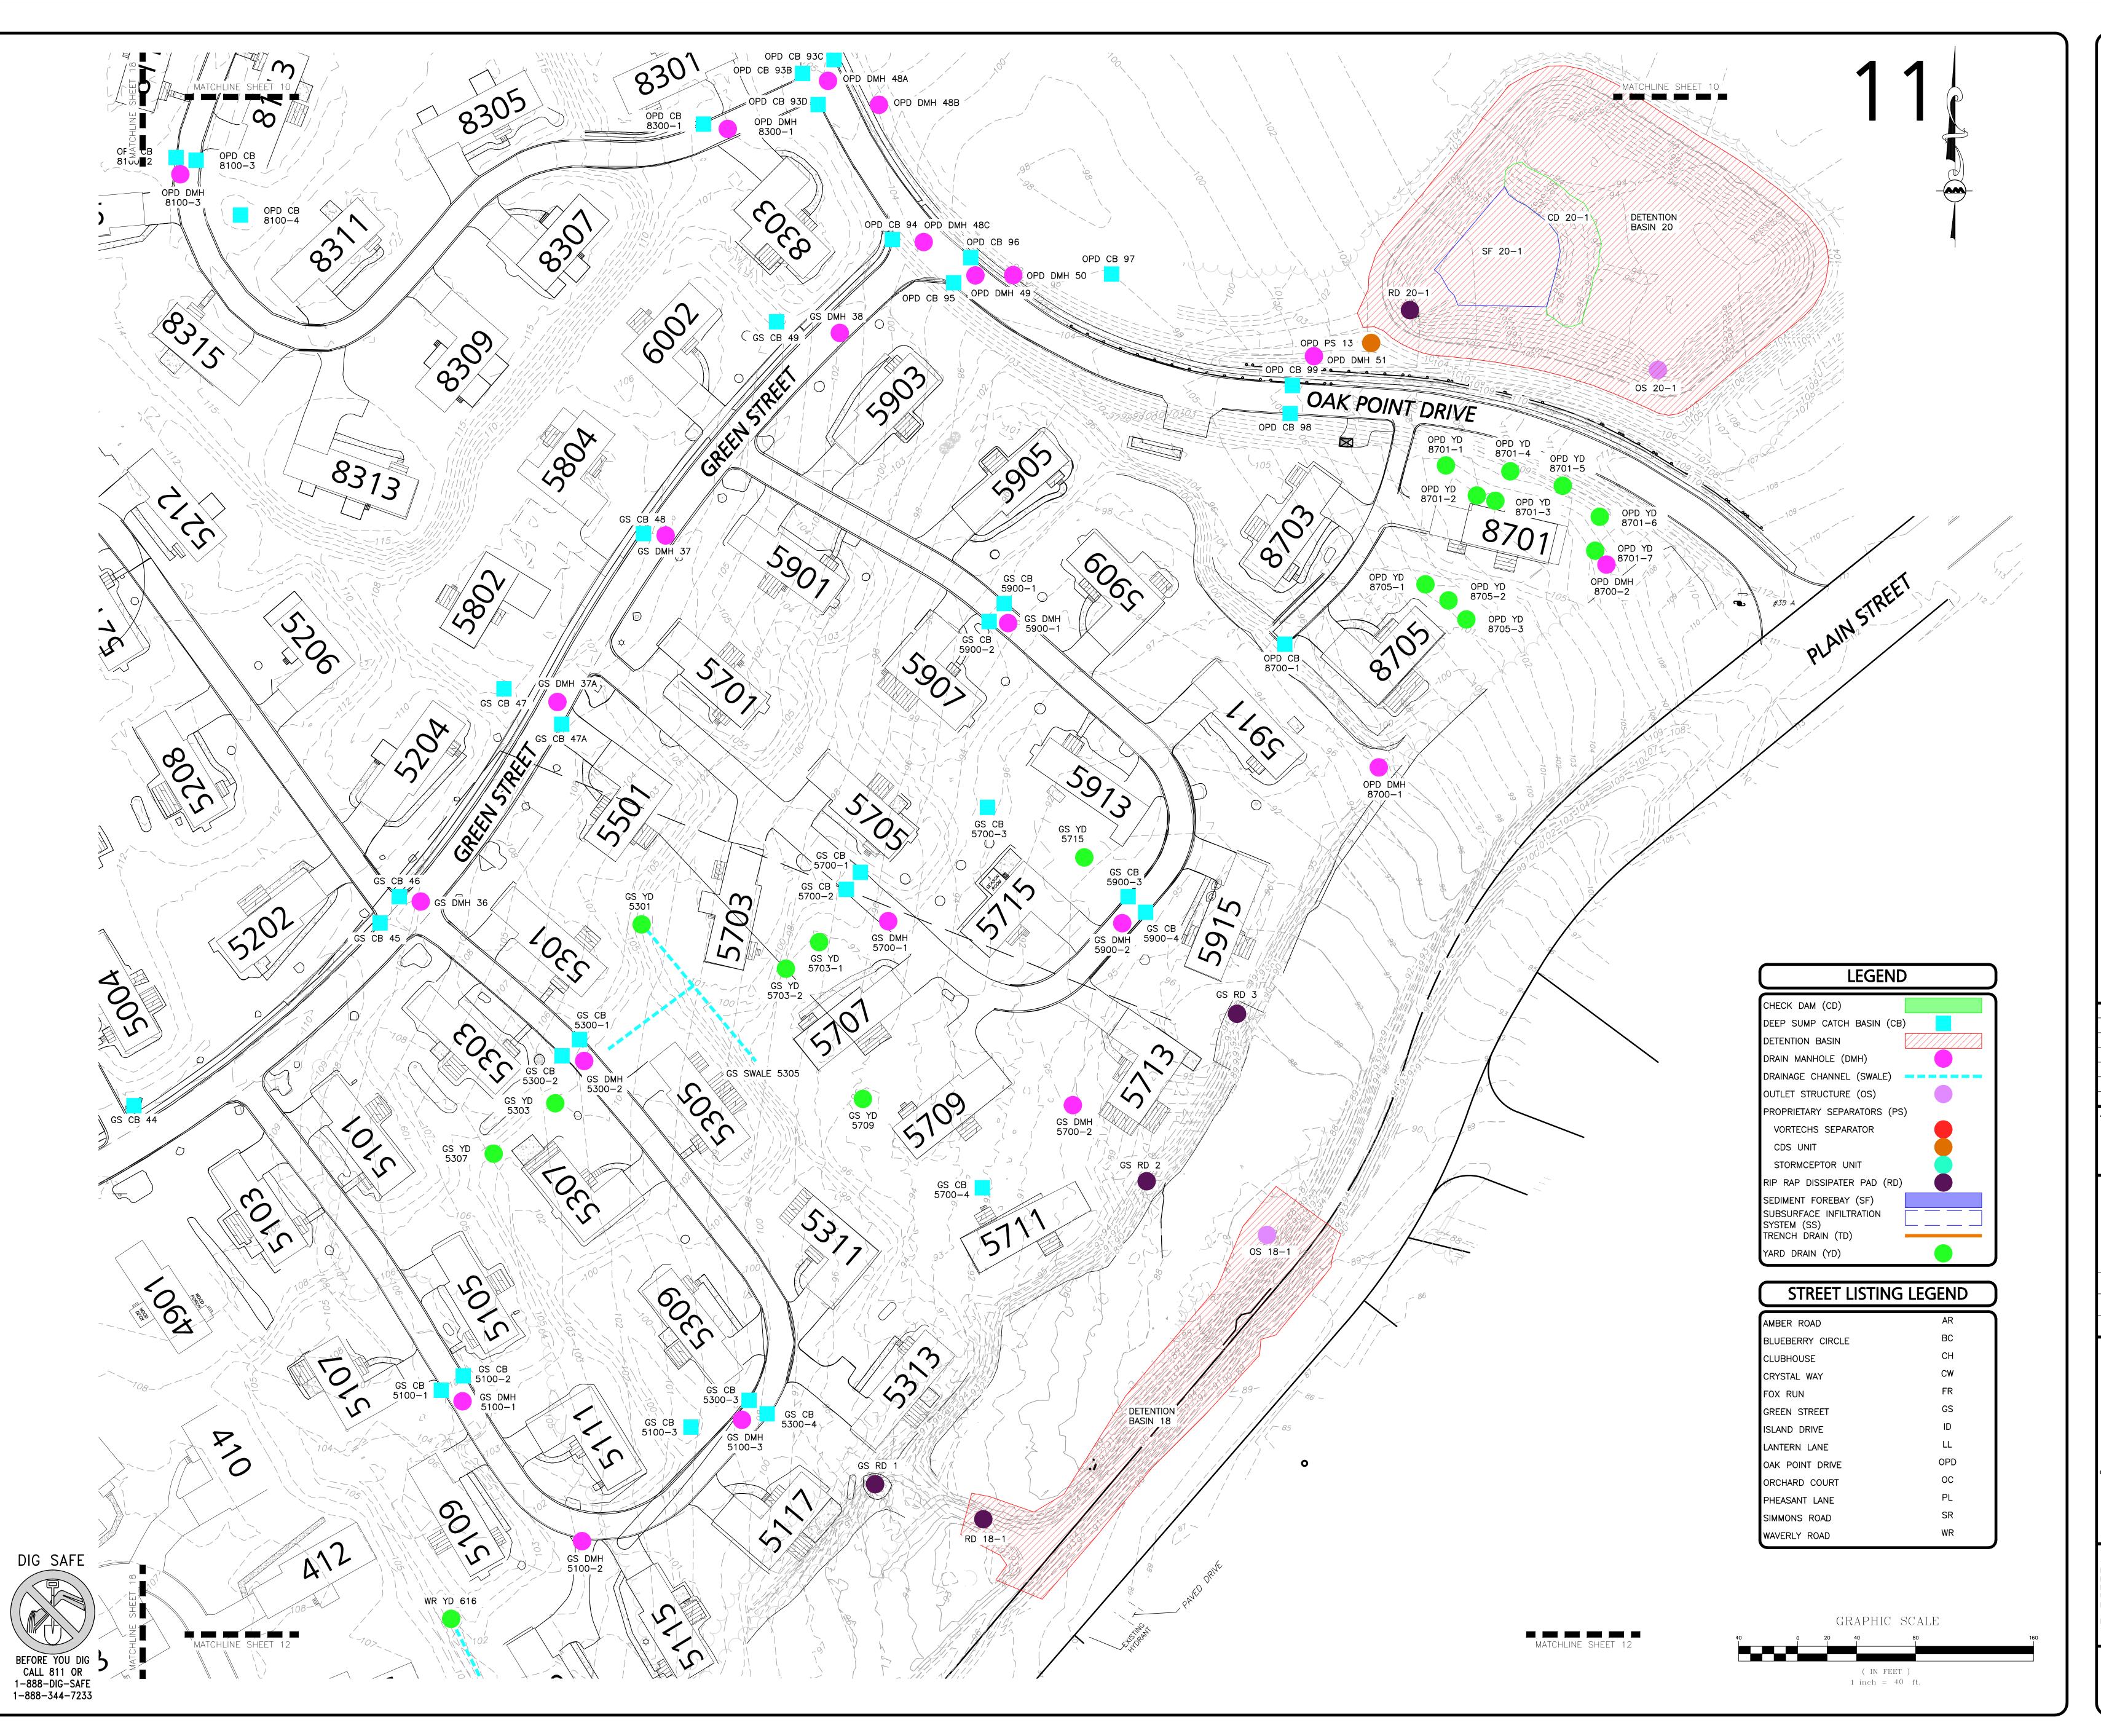
THE INFORMATION ON THIS PLAN HAS BEEN COMPILED FROM VARIOUS RECORDS INCLUDING ON THE GROUND SURVEY, RECORD PLANS, GPS LOCATIONS AND SWING TIE DATA. IT IS INTENDED TO PROVIDE A GRAPHICAL REPRESENTATION OF STORMWATER ELEMENTS FOR GENERAL LOCATION AND MAINTENANCE USE. EXACT POSITION OF STRUCTURE MAY VARY FROM PLAN.

THIS PLAN DOES NOT DEPICT ALL UTILITIES OR SURFACE FEATURES.

THIS PLAN SHOULD BE USED IN CONJUNCTION WITH THE WRITTEN STORMWATER OPERATION AND MAINTENANCE REQUIREMENTS.

- A&M inspected the rip rap disaster pads identified on the enclosed Locus Site Plan during the Q1 Inspection.
- O A&M observed a number of structures that were recommended for cleaning/clearing due to fallen leaves and tree debris, vegetation overgrowth, and/or sediment accumulation. Additionally, A&M identified an isolated instance of a runoff swale at the end of a rip-rap that needed to be smoothed.
- o All of A&M's recommendations were acted on and completed by Oak Point Maintenance Staff in June 2023.

- o A&M inspected the sediment forebays identified on the enclosed Locus Site Plan during the Q1, Q3, and Q4 Inspections.
- o Based on its observations, A&M did not recommend that any maintenance work be performed on these structures.

- o A&M inspected the subsurface infiltration systems identified on the enclosed Locus Site Plan during the Q1, Q3, and Q4 Inspections.
- o Based on its observations, A&M did not recommend that any maintenance work be performed on these structures.

Hometown Oak Point has confirmed with A&M that the plan and index revisions are not the result of any discovery of missing system structures, and that the stormwater system at Oak Point is functioning as intended. The original Locus Site Plan was created from a compilation of record data concerning the development of Oak Point since its inception in the late 1990s, and was not the result of any previously-conducted comprehensive on-theground A&M survey for purposes of plan preparation. A&M's comprehensive field review of every system component during its first quarterly inspection led to the identification of certain duplicate labels, labeling errors, and/or duplicative listings of structures in the record documentation.⁴ Overall, there are relatively few corrections and additions in the revised plan and index, given the size and scale of the Oak Point Stormwater Management System as a whole.
